Farm Dairy Effluent Irrigation Evaluations

Spitfire Effluent Irrigator

Spitfire effluent irrigation evaluation

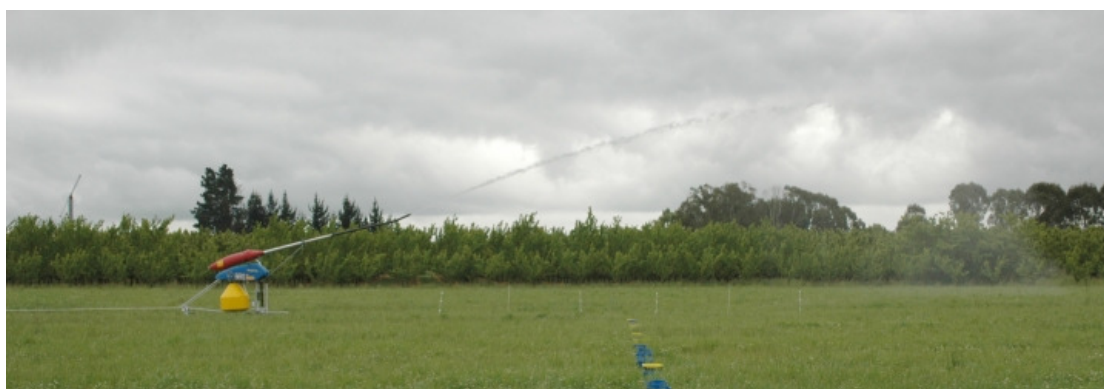
Figure 1. Effluent irrigator crossing the catch can transect

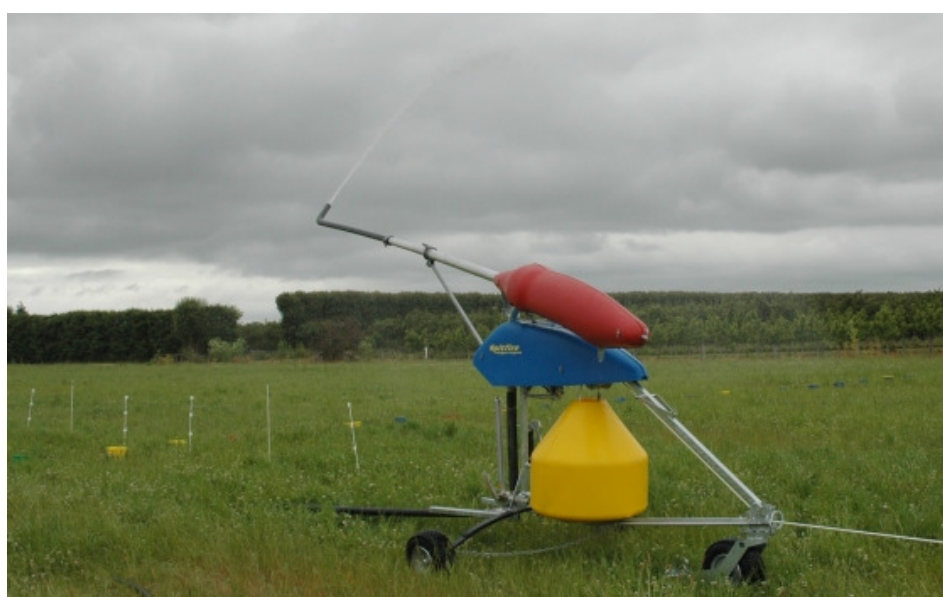
Figure 2. Spitfire with oscillating nozzle

- Spitfire Irrigators Ltd,
266 Normandale Rd,
Lower Hutt City,
WELLINGTON, NEW ZEALAND, 5010
www.spitfire.net.nz
- Medium traveller with rubber orifice on oscillating boom
 - new Spitfire irrigator
 - Wetting width approx 30m
 - Overlap optimised ~ 26 m

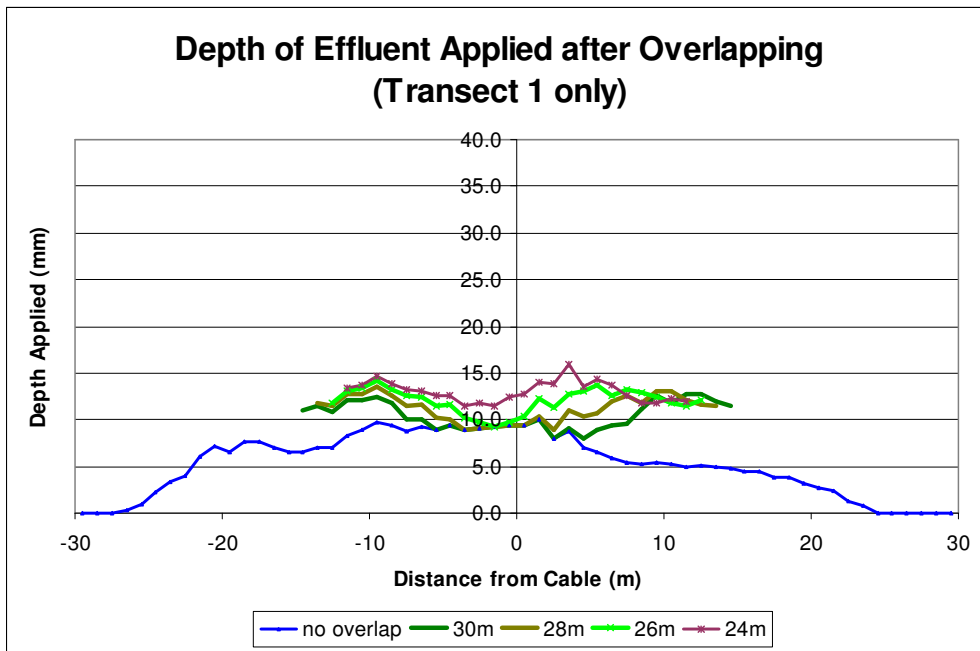
Figure 3. Effluent application pattern measured at 275kPa pressure and full machine speed with no overlap (blue line) and calculated overlapped pattern based on 30, 28, 26 and 24m run spacings

- The wetting pattern was typically triangular, with good uniformity after allowing for appropriate over-lap.
- The nozzle arrangement does cause the spray jet to rise relatively high. At the settings used for testing the pattern was affected by even relatively light winds. However, as shown in Figure 3, the application pattern still gave reasonably good uniformity after allowing for overlap. Testing was discontinued if mean wind speed rose above three metres per second.

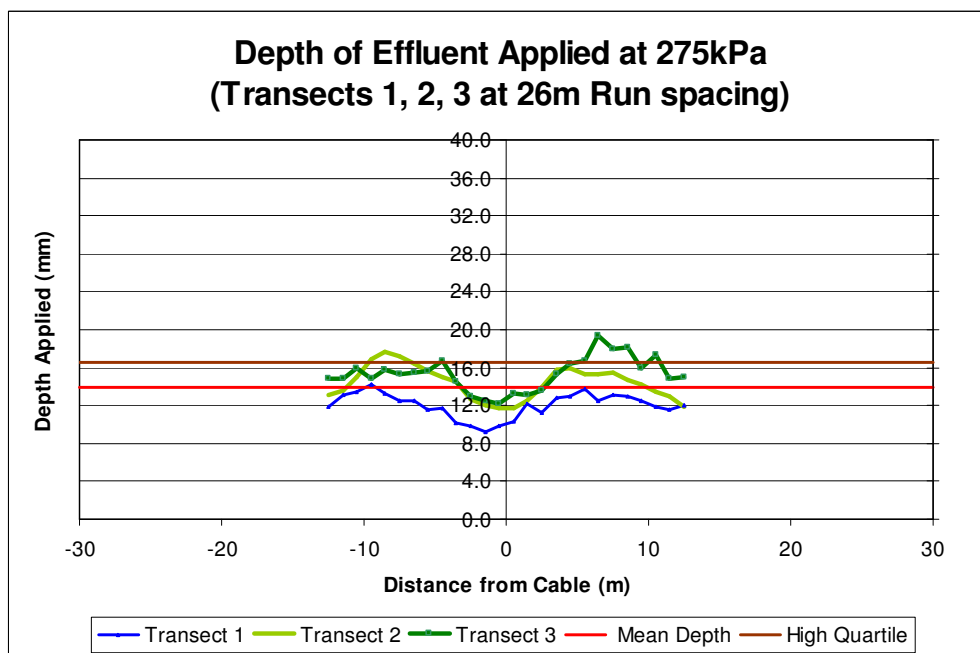
Figure 4. Effluent application pattern of three transect along a single run, measured at 275kPa pressure and full machine speed with calculated overlapped pattern based on 26m run spacing

In the graph (Figure 4), the applied depths after allowing for 26 m run spacing are shown as the solid green and blue lines. The High Quartile and Mean Applied depths are shown as the orange and brown dashed lines.

One eighth of the effluent application area receives more than the High Quartile Depth, 7/8th of the area less than the High Quartile. It is important to consider the summed values from all transects across the entire effluent application area to determine a "Field Uniformity" value.
